DESIGN MEMORANDUM
ON
NANTUCKET HARBOR, MASSACHUSETTS
(MINOR REHABILITATION - EAST JETTY)

U. S. ARMY ENGINEER DIVISION, NEW ENGLAND

4 May 1962

NANTUCKET HARBOR, MASS.
REHABILITATION OF EAST JETTY

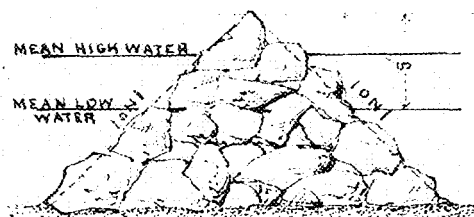
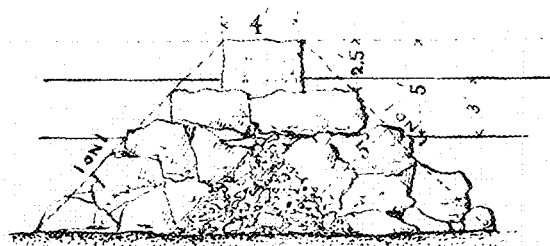
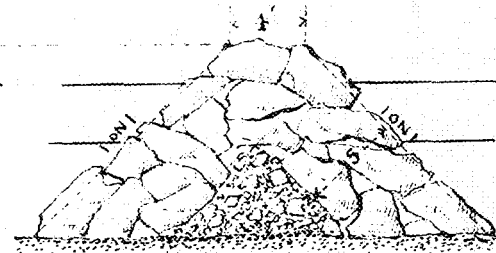
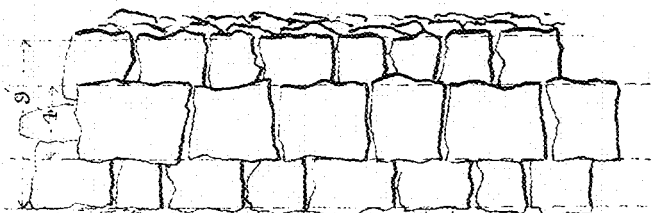
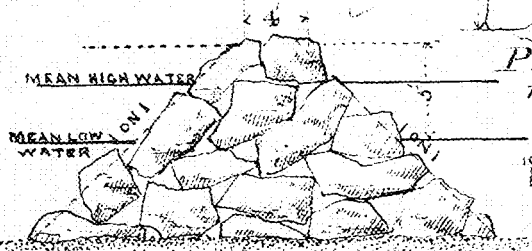
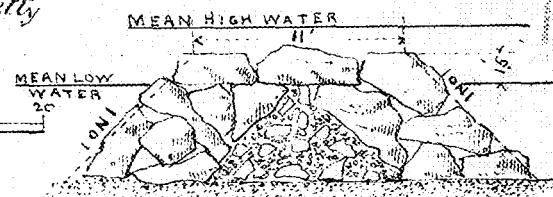
10. The first project for jetty construction was adopted in 1880 when construction of the west jetty was started. This project was based on a report made in 1879 printed in House Document No. 18, 45th Congress, 2d Session which contemplated a jetty having a top height of 5 feet above mean low water, triangular in section for a distance of about 4,000 feet and then 4 feet wide on top for the outer 2,500 feet with side slopes throughout of 1 on 1. The purpose of the jetty was to concentrate the ebb tide to encourage scour in the entrance channel to attain a depth of 12 to 14 feet, and to prevent littoral drift from filling in the channel. It was considered at the time that a jetty on the east side of the harbor might be necessary. Dredging was not contemplated. During construction of the west jetty, careful observations were made to determine the effect of the structure with the view that if the west jetty failed to produce the desired scour, the east jetty would be started. By 1885, 3,955 feet of the west jetty was constructed with no appreciable affect on the depth of water in the channel. Based on a study made in 1885, the results of which are contained in the Annual Report of the Chief of Engineers of 1885, the project was modified to provide for construction of the east jetty. Under the new plan, a location and design for the east jetty was adopted and a 15-foot channel was to be obtained by dredging, if found necessary. The east jetty was to have the same trapezoidal full section as the west jetty for a distance of 2,500 feet from shore and then a half-tide section for the remaining distance of about 4,500 feet out to the 15-foot contour, a total distance of about 7,000 feet. Cross sections are shown on Plate 1.
